# PRODUCT DEVELOPMENT

P E R S P E C T I V E S F R O M A D E S I G N E N G I N E E R

R I C H A R D P Y A T T

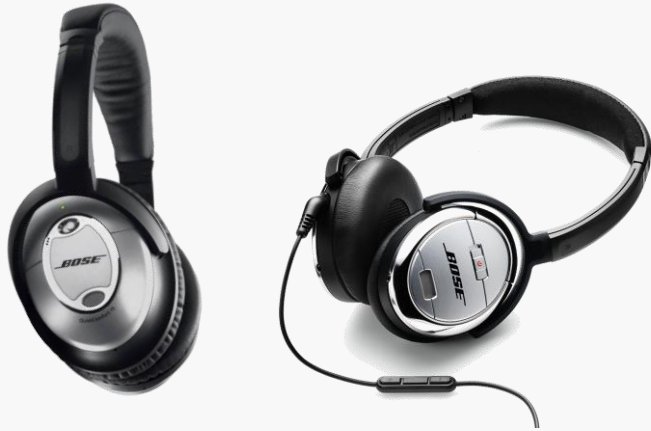
**Banded Headphones**

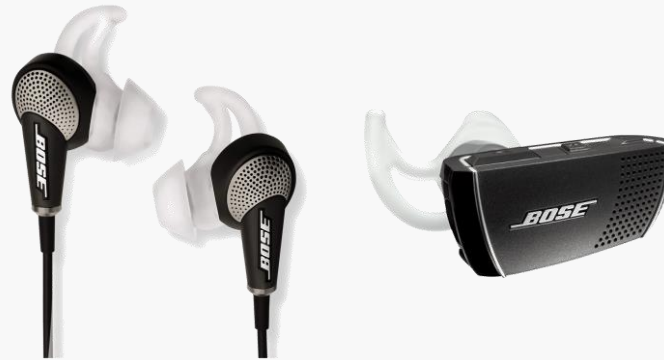
**In Ear Headphones**

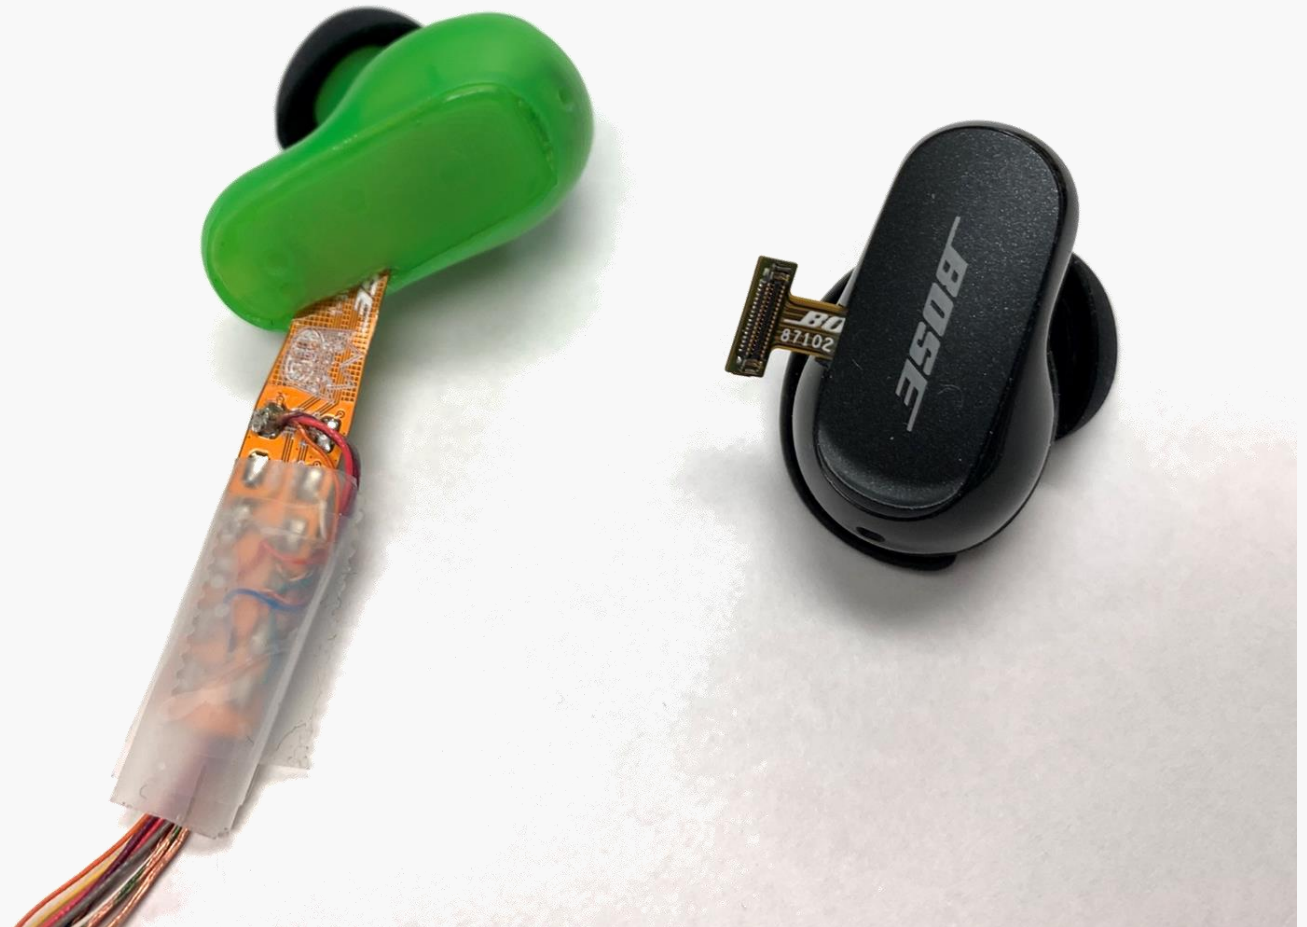
Form factor integration of all components. Mix of some prototype and some manufactured parts. Some allowances for test interface remain. Product is generally usable but may not be feature complete.

FW functionality is maturing.

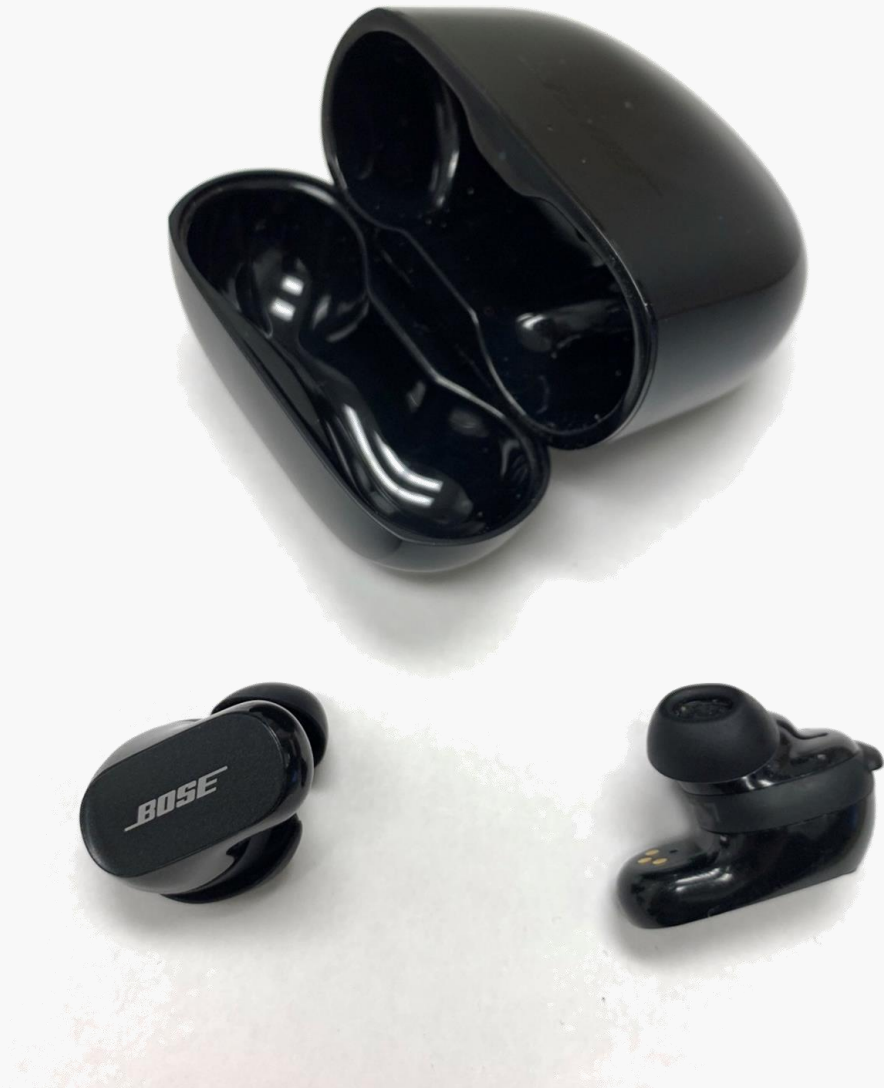
## 04 | Final Product

Fully realized product, with full functionality. Production parts and assembly processes. Intended user experience.

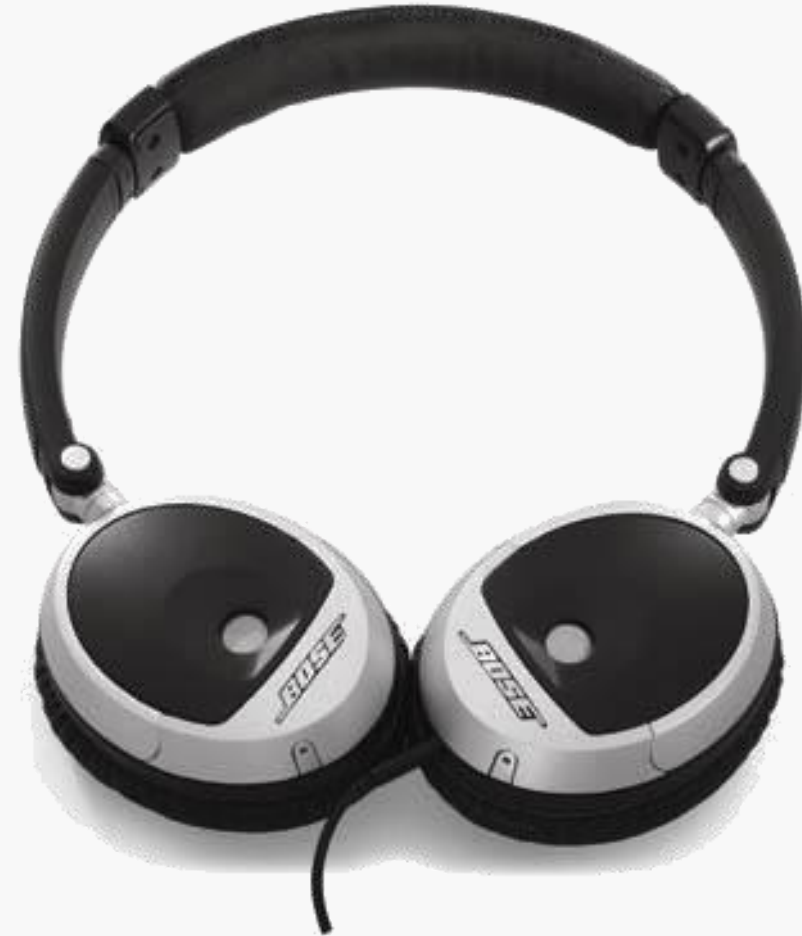
Wired, passive audio playback headphone

New on-ear form factor and acoustic design

Decided to use a new supplier for acoustic mesh

New manufacturing partner building the product

## Build 1 - Acoustic Response Issue

First build at factory

Acoustic output not meeting expectation

Root caused to port impedance - too high, caused by acoustic mesh resistance out of spec

Decision: Provide qualified mesh material with known characteristics from known supplier for next build

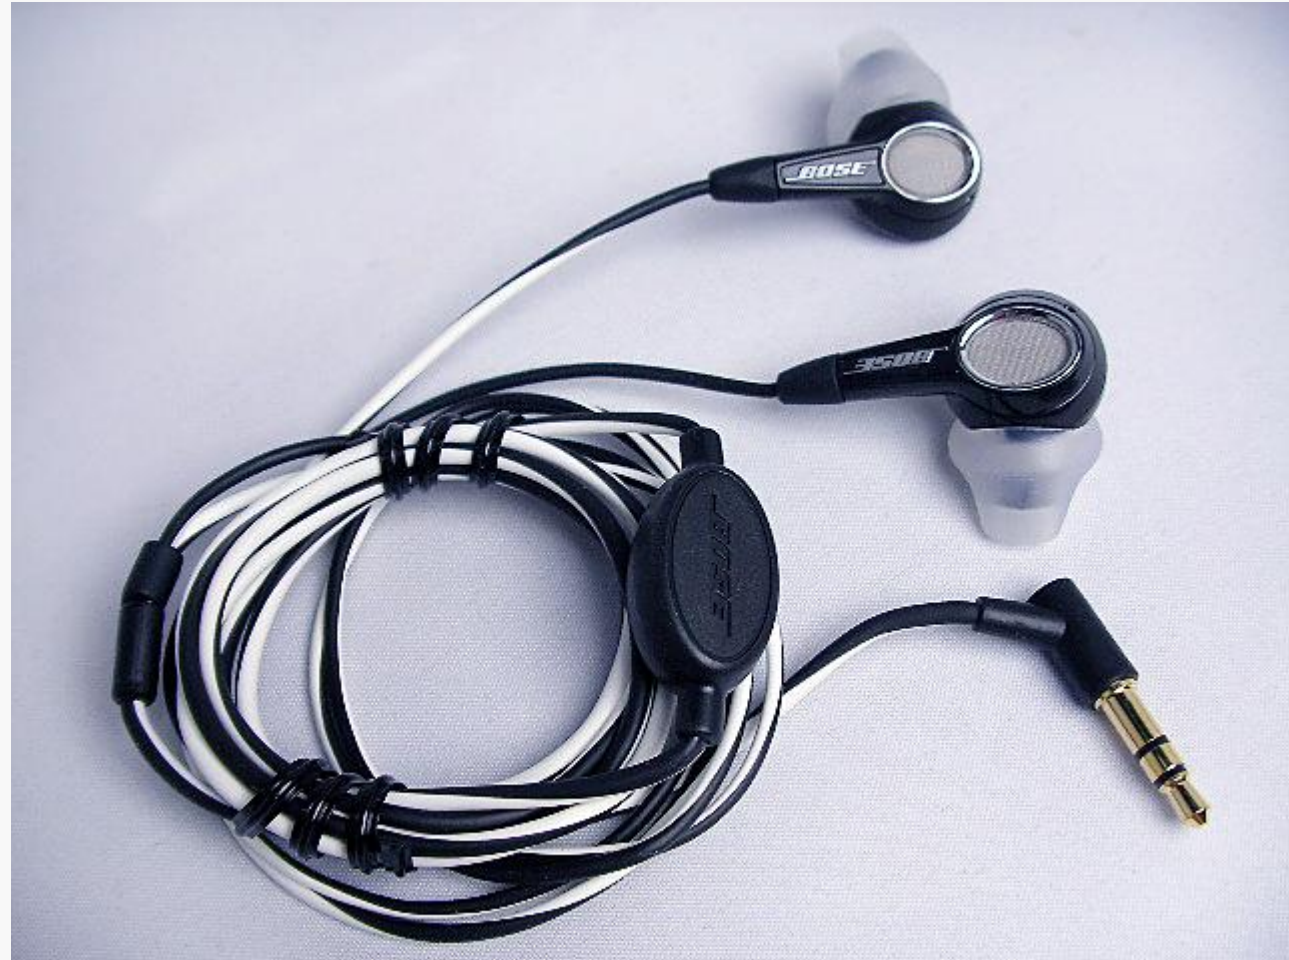
Wired, passive audio playback headset

First in-ear headphone developed at Bose

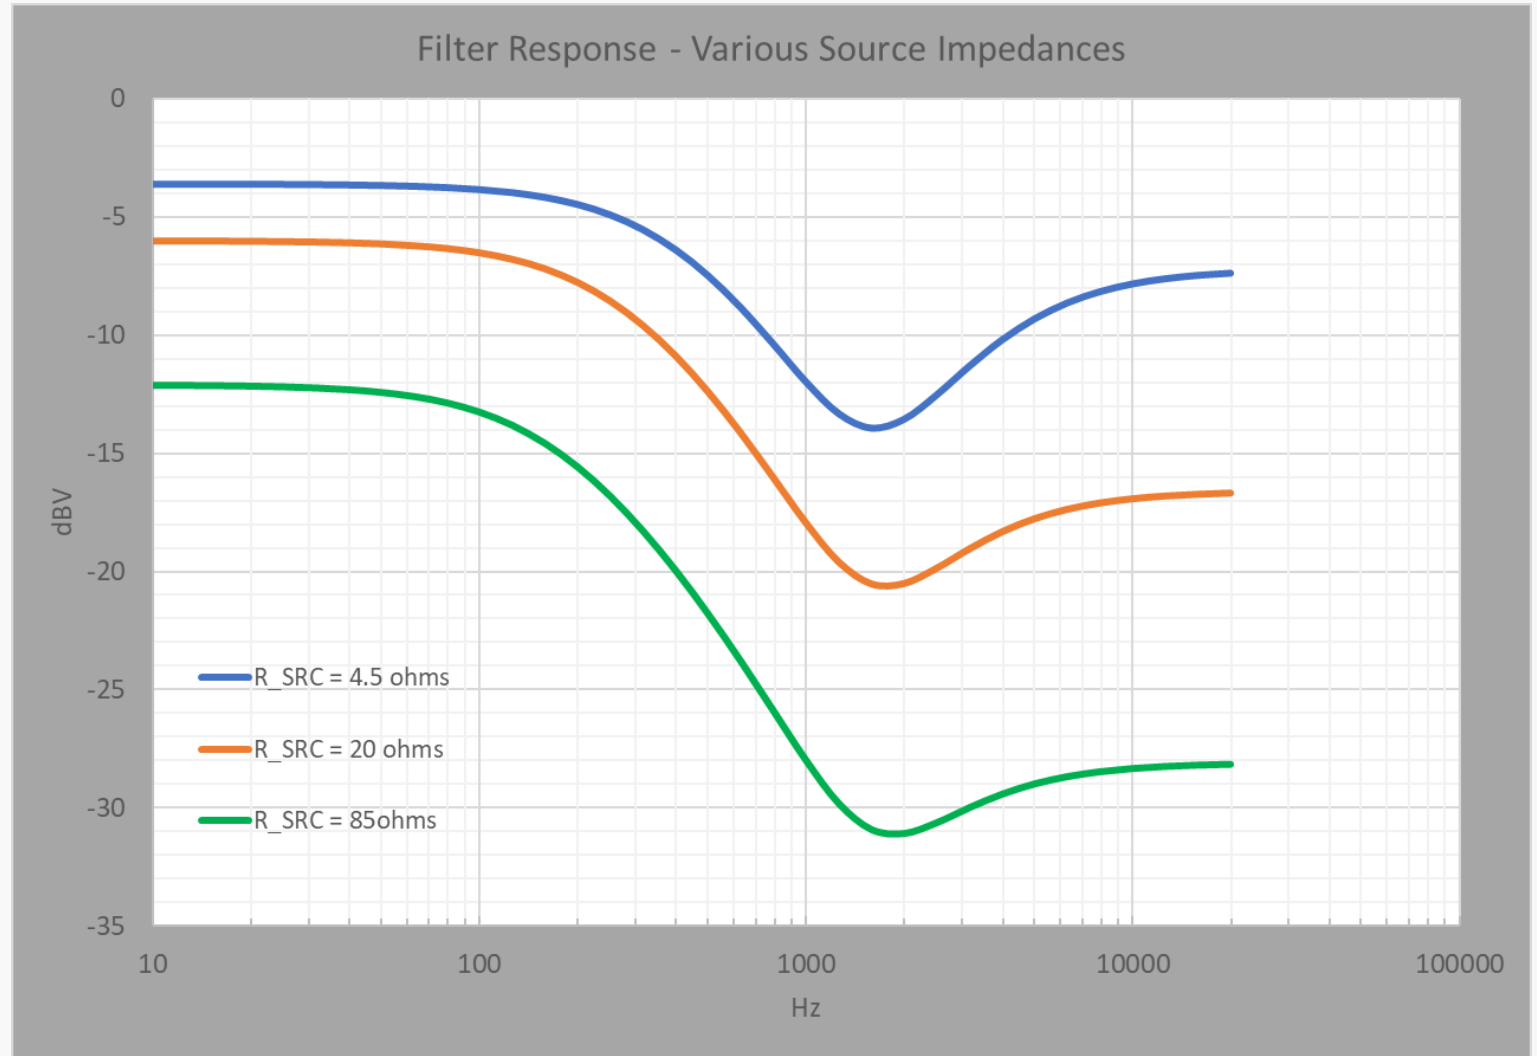
Most portable players had an internal source impedance of about 4.5 ohms.

But devices varied considerably. Upon completing a survey of a wide variety of players, some were as high as 85 ohms!

This had significant impact on both output volume as well as EQ shape

Possible solutions included modified filter circuit (increased cost, physical size) or modifications to physical acoustics (long lead time, expensive to re-tool parts)

Decision not to make any design changes

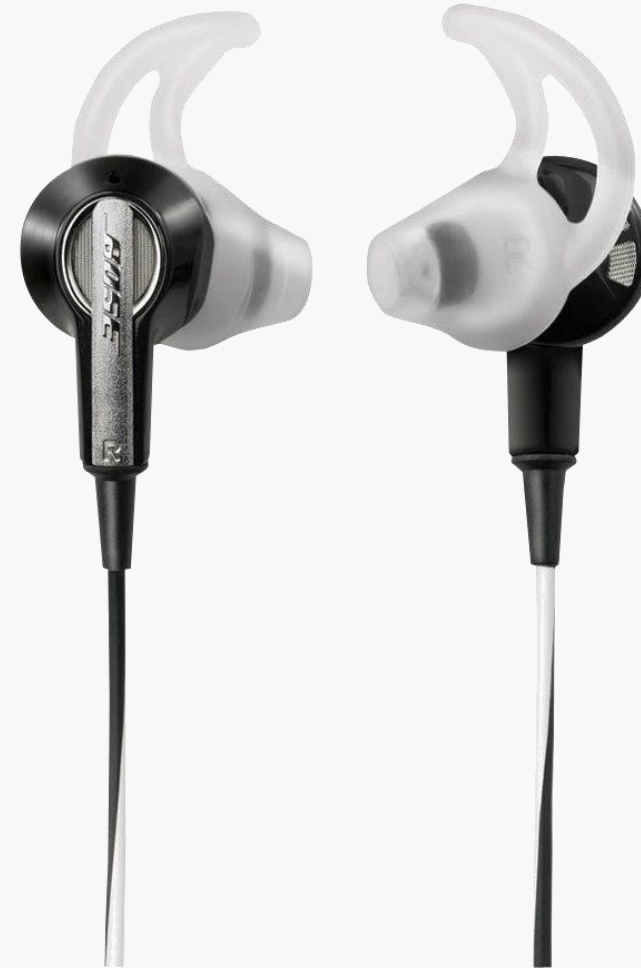
2<sup>nd</sup> generation of wired, passive in-ear headphones

Included a new passive EQ circuit immune to source impedance induced variation

Root cause: static buildup dissipating from ear to ground through the earbud itself (plugged into ground via treadmill).

Changed plastic resin to include metal powder content

This reduced the impedance of skin contact with the bud housing, allowing the ESD to discharge unnoticeably at a lower voltage.

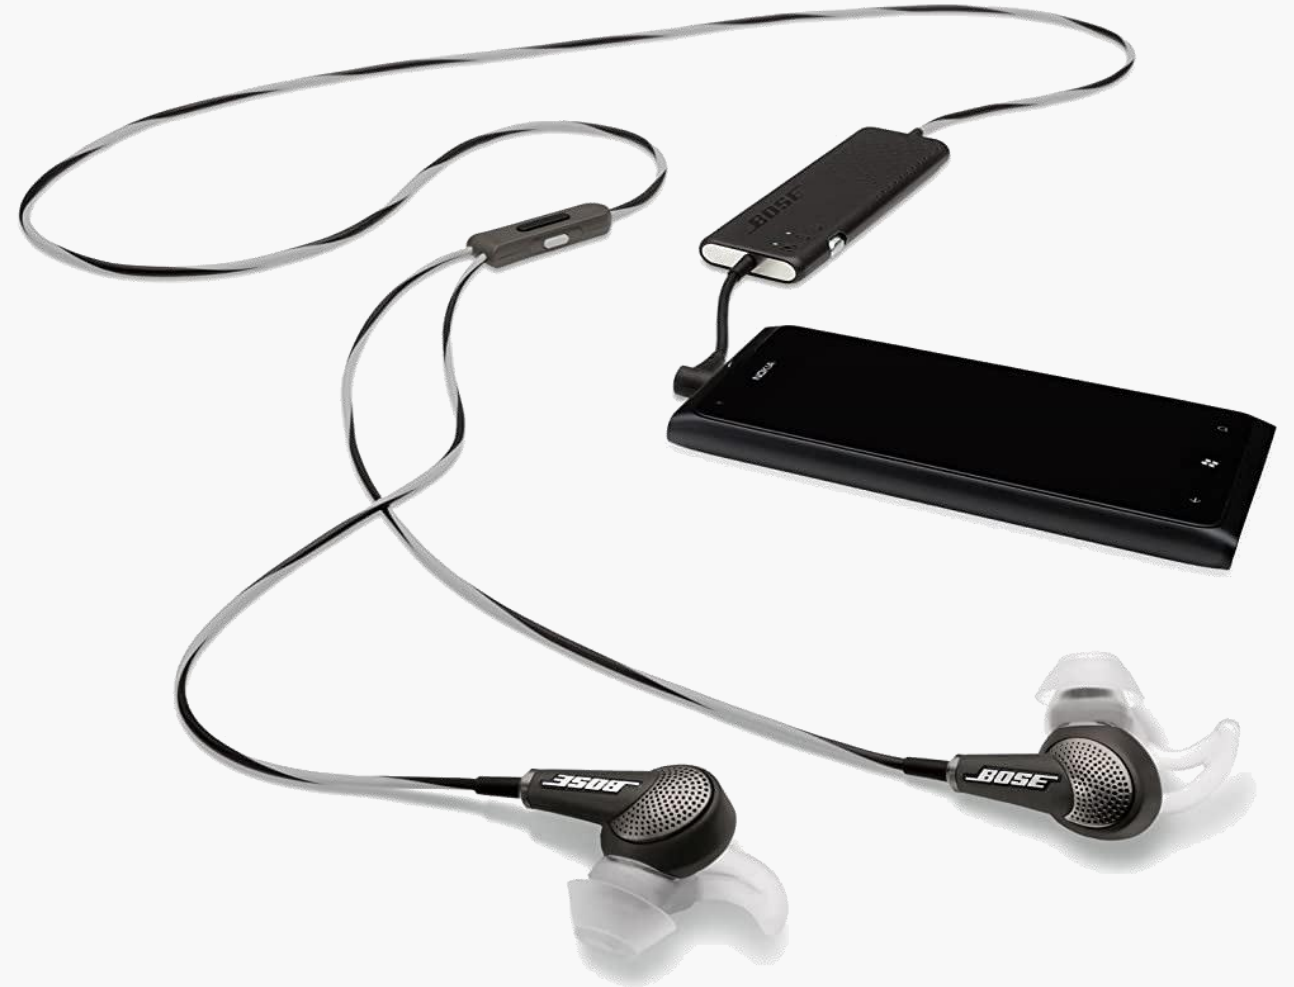
Audible “tic” sound could be heard under certain conditions in some units

- Noticeable with high impulse, low frequency stimuli
- Noticeable when putting the buds into your ears while powered on, pushing on buds in ears
- Did not occur when unpowered

Small percentage of units exhibited behavior, so few samples to analyze (~3 units)

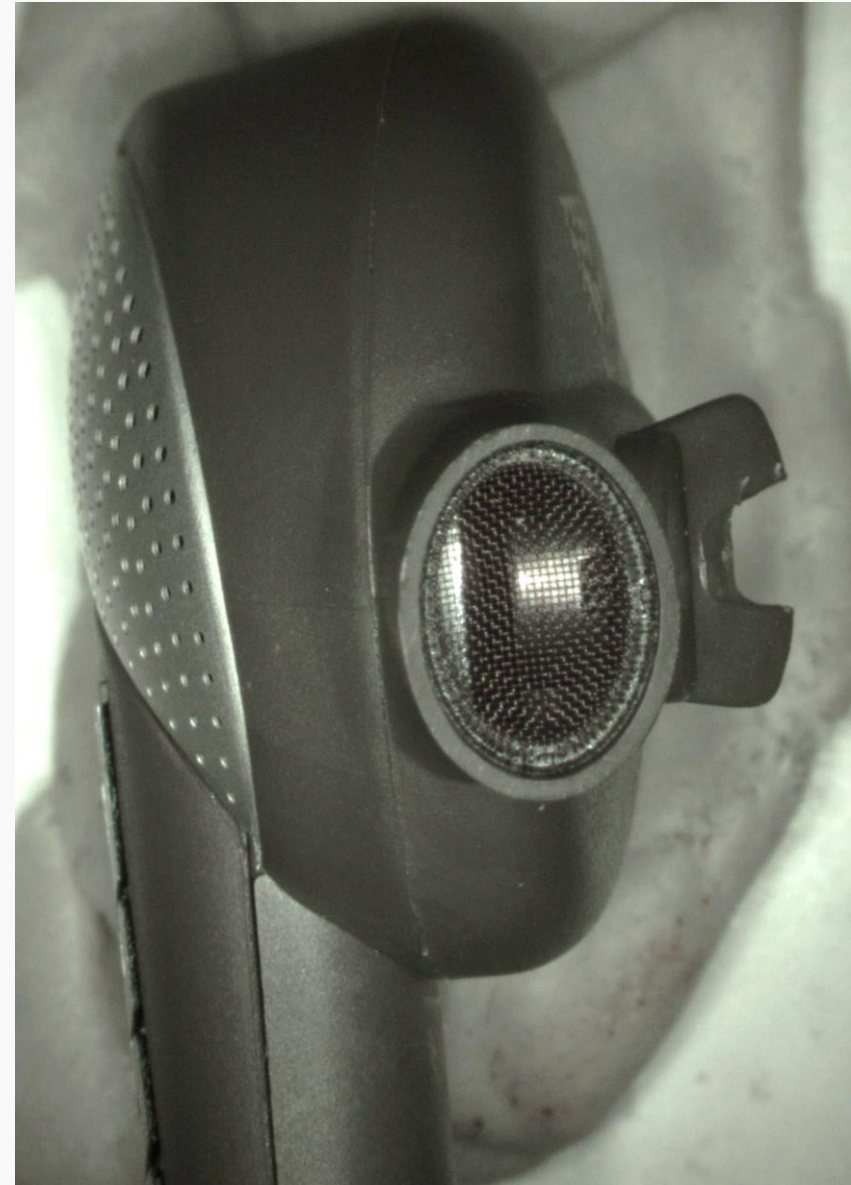
Drive driver with high system voltage, measure response at feedback microphone

Tear down analysis, recognizing risk of losing evidence

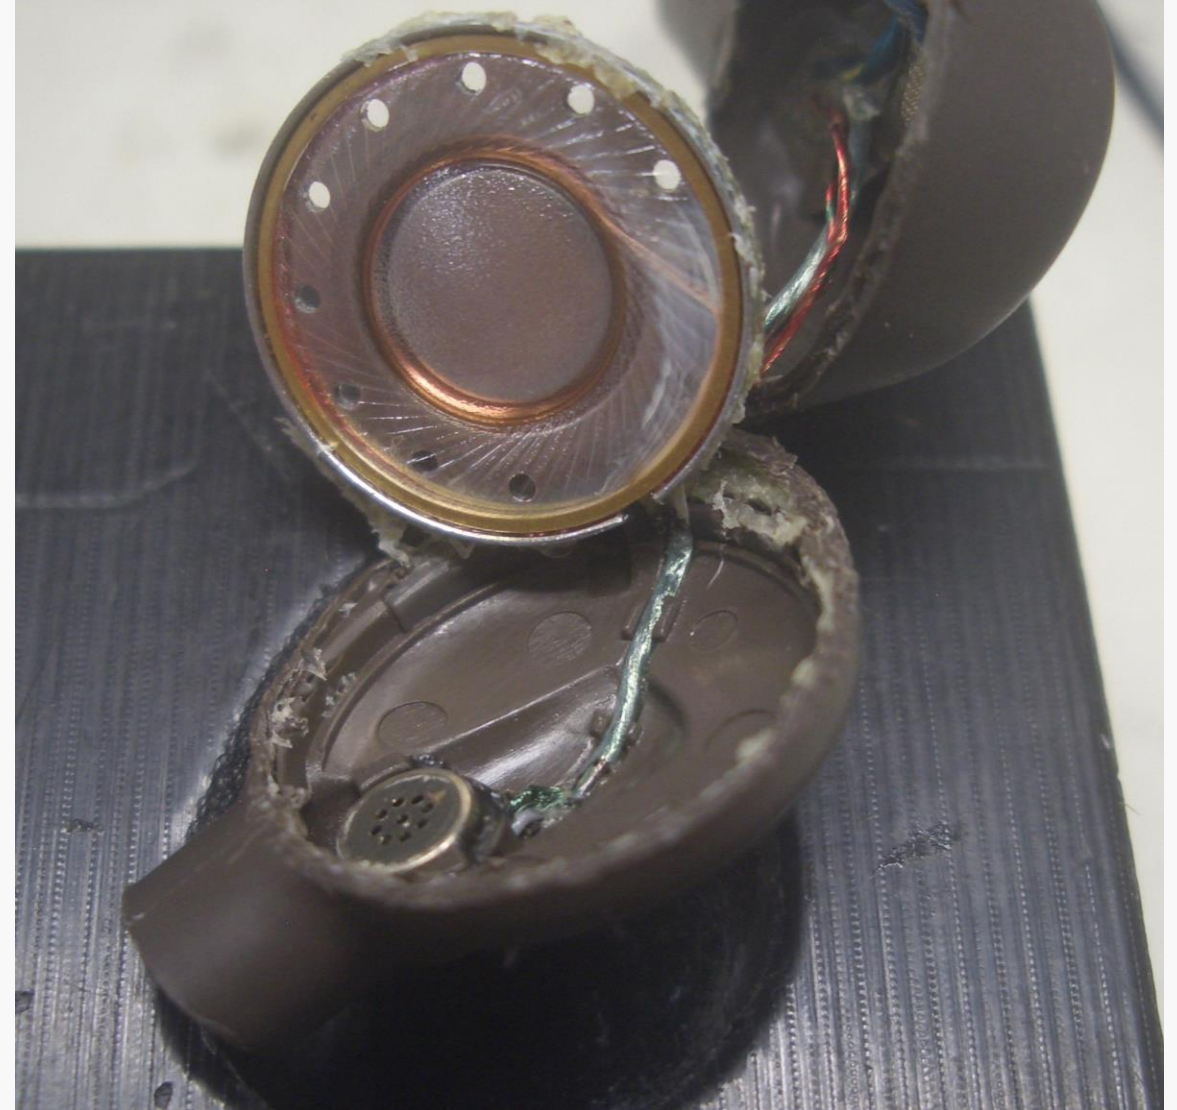
Loose fibers from mic wire bundle inside front acoustic volume could contact driver

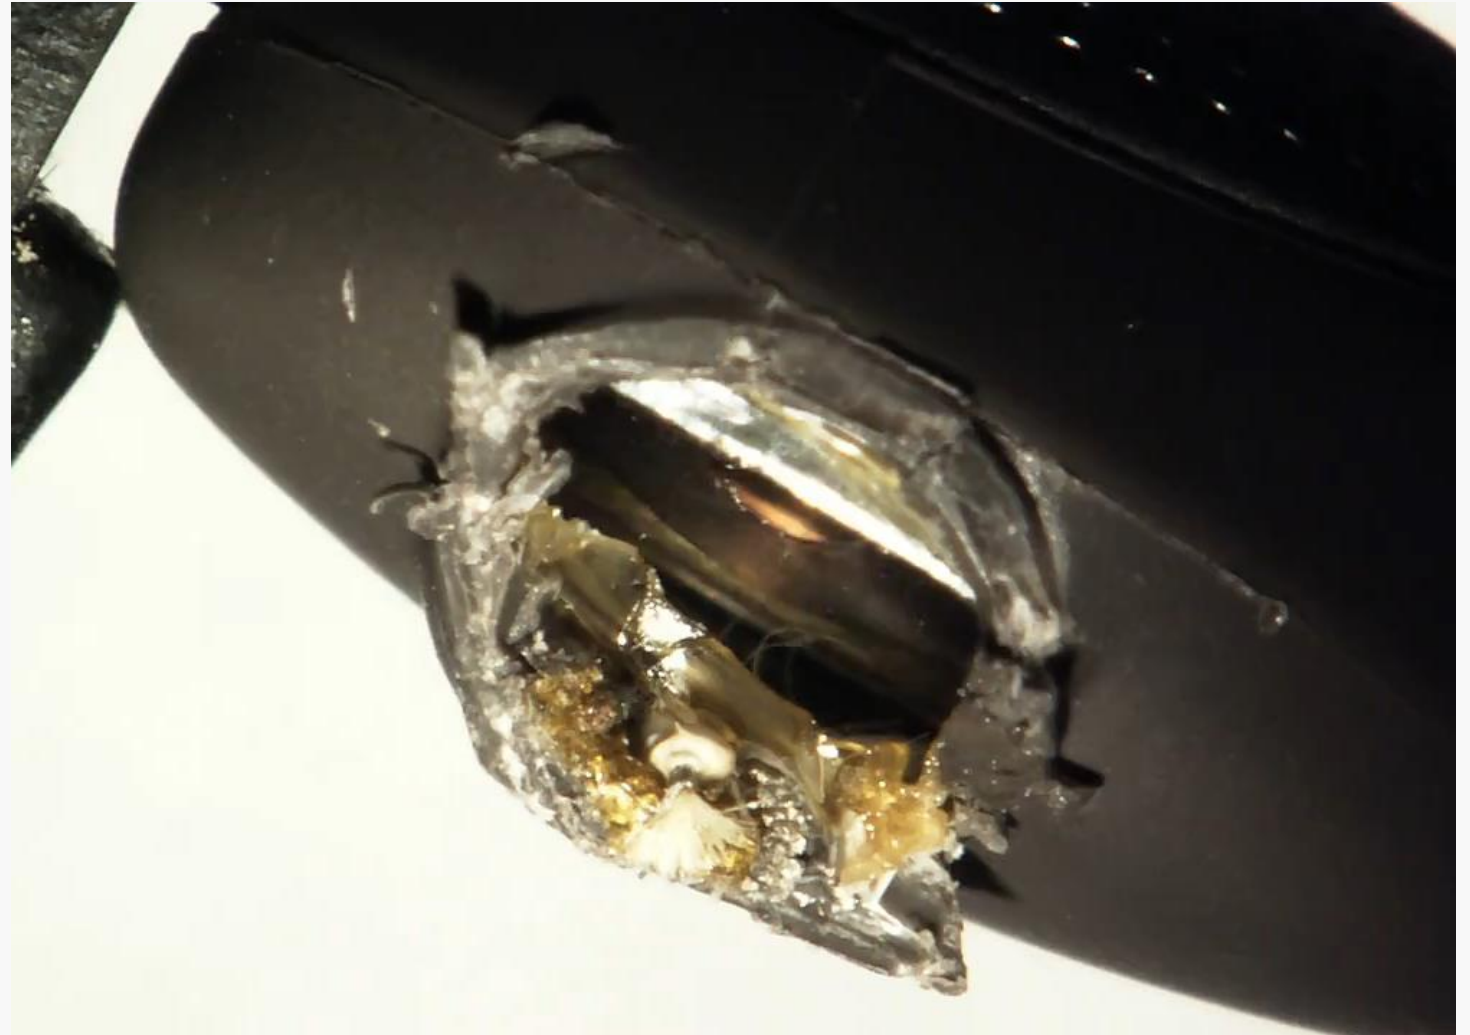
600mV @ 8Hz

Driver diaphragm hits fiber strands

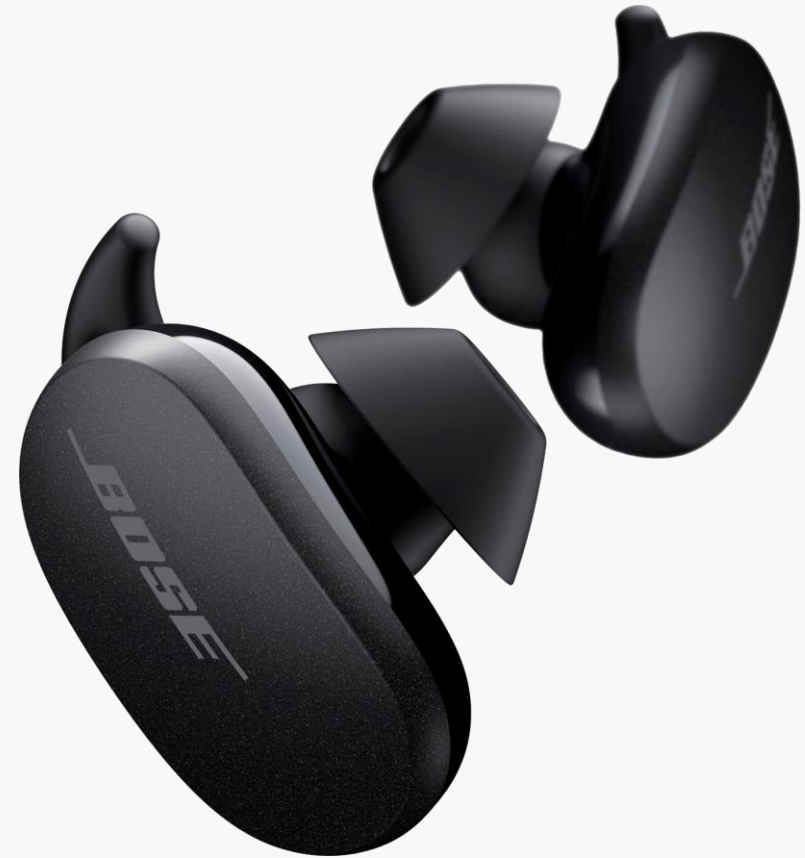
Some motion detectors utilize sensors that emit ultrasonic sound energy in the 30-50kHz range.

High output levels are enough to saturate or clip the microphone input, causing unpredictable overload behaviors.

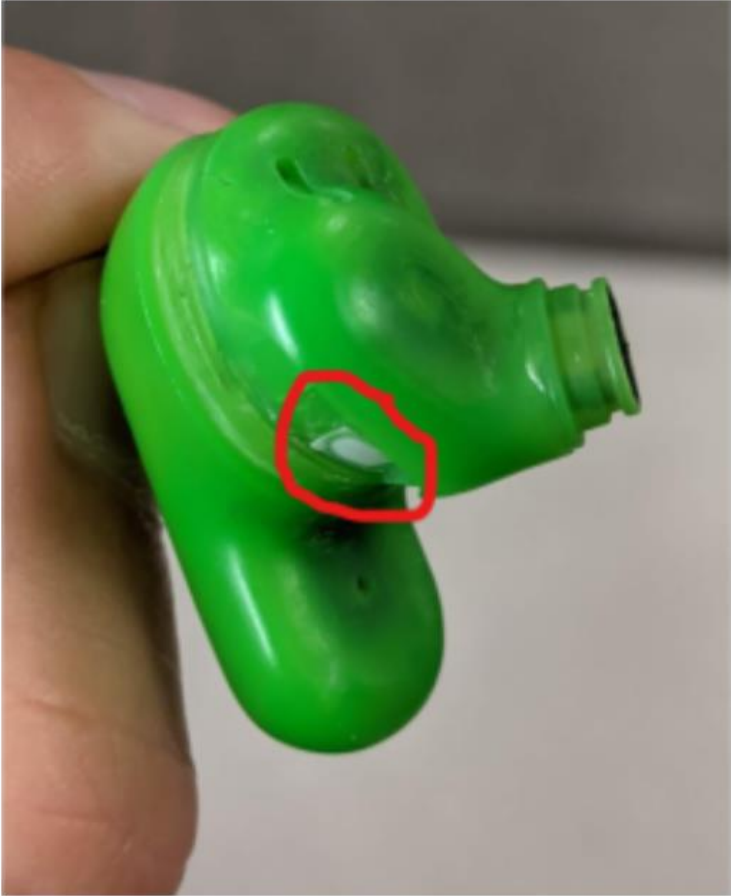
New

Relocate port exit to prevent occlusion

No perfect solution, but had to choose best compromise

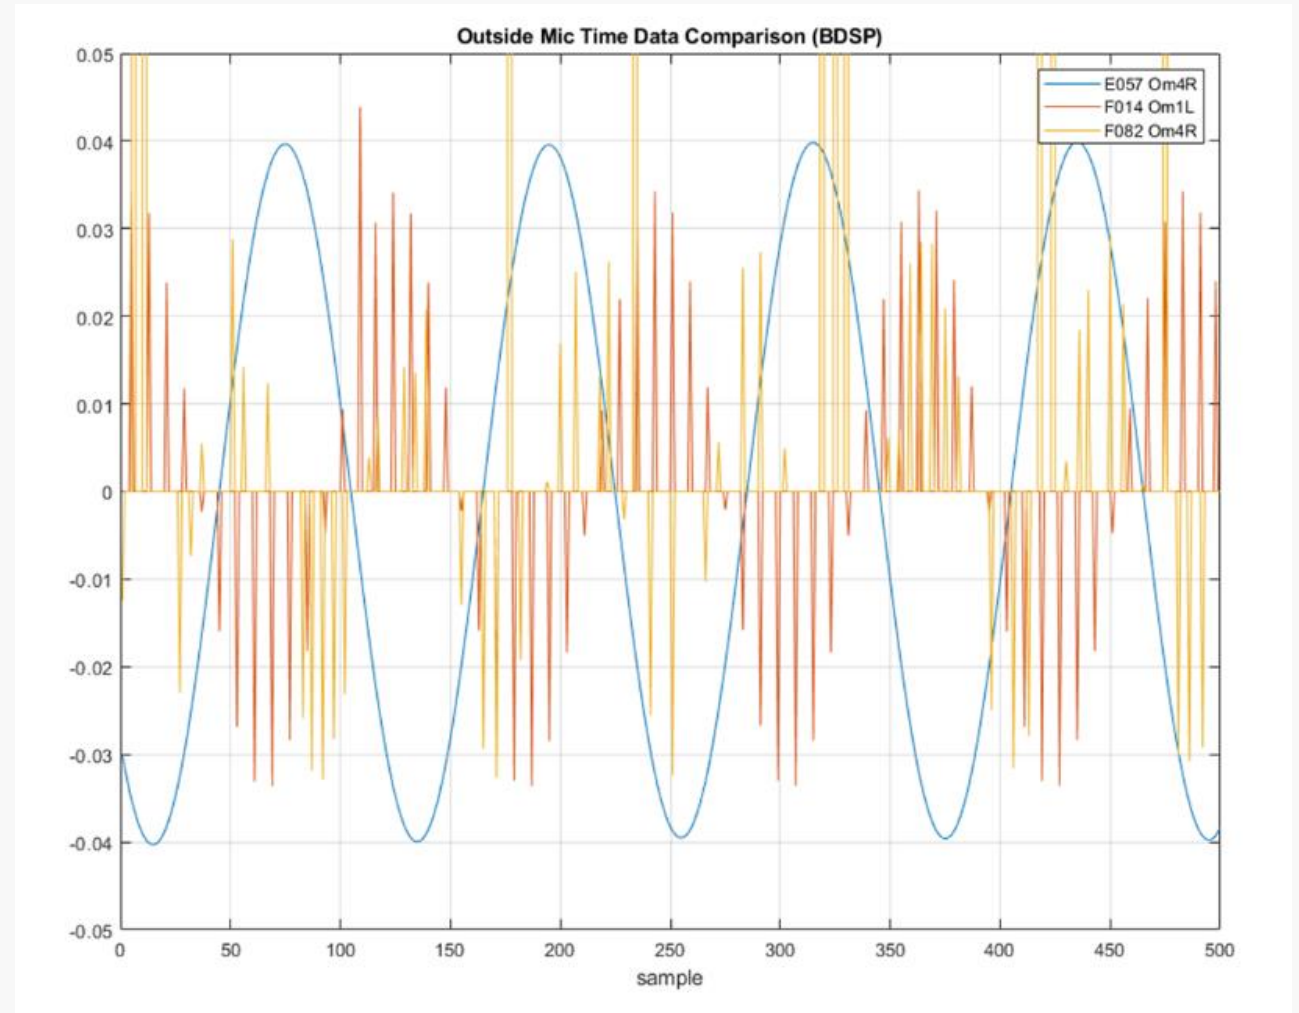
Check time series data

Noticed many samples were zeroed out on bad units
